## CASE STUDY

Allseas UK has been engaged in the installation of the Production Flowlines from Laggan-Tormore to the Shetlands and the Export Pipeline from the Shetlands to the MCP-01 platform for the development of the Total Laggan and Tormore gas fields situated some 125km north west of the Shetland Islands. The FL2, Flowline 2 has been damaged due to a dragged anchor from a passing vessel. As such, suffered local buckling and therefore required rectification works of cutting out and replacing the damaged pipework.

In February 2014 UCS were contacted by Allseas to supply all relevant equipment and technicians to assist in the rectification works

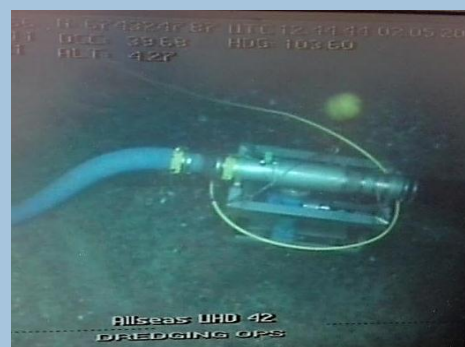
*8" Dredge System*

First part of the project was to dredge a channel under the damaged pipework. This was carried out using UCS 8" dredge system modified and fitted with specially designed high pressure barracuda head. The set up proved to be effective in the dredging operation.

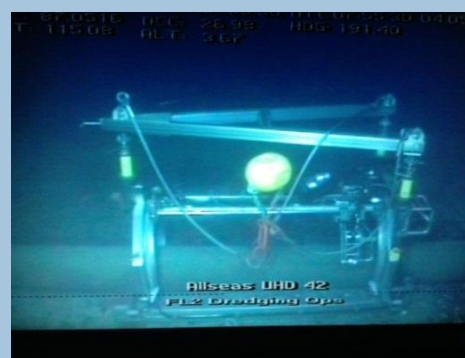
*Coating Removal System*

The coating Removal tool worked effectively on the removal of 1.2mtrs. of the concrete coating and the 3LPP undercoating.

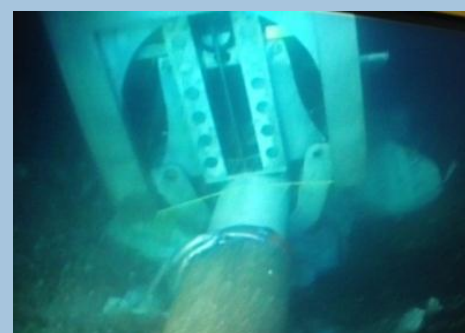
*42" Diamond Wire Saw*

UCS's 42" Diamond Wire Saw completed 6 cuts with an average time of 44 minutes per cut.

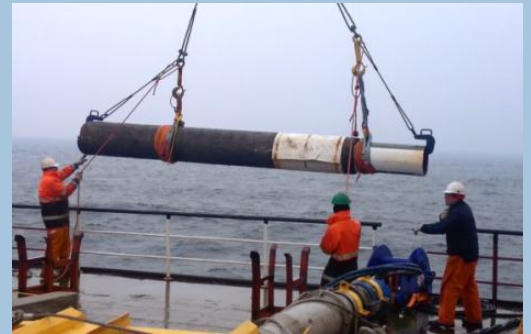
Pipe Recovery

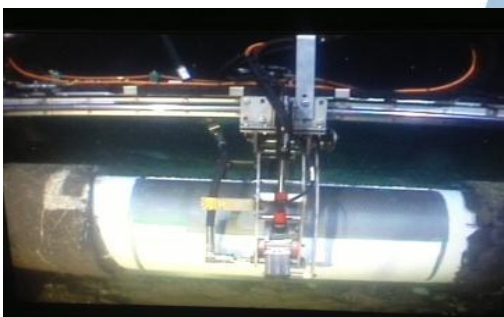
Coating Removal System
